Subject: Request for Proposal (RFP) for an Initial Study for the Installation of a New Force Main Pipeline, Repairing Pump Station to include Telemetry Equipment.

Project Name: Initial Study for Country Club Sewer Maintenance District (CCSMD).

PRELIMINARY ENGINEERING REPORT (PER) FOR FORCE MAIN REPLACEMENT AND PUMP STATION UPGRADES

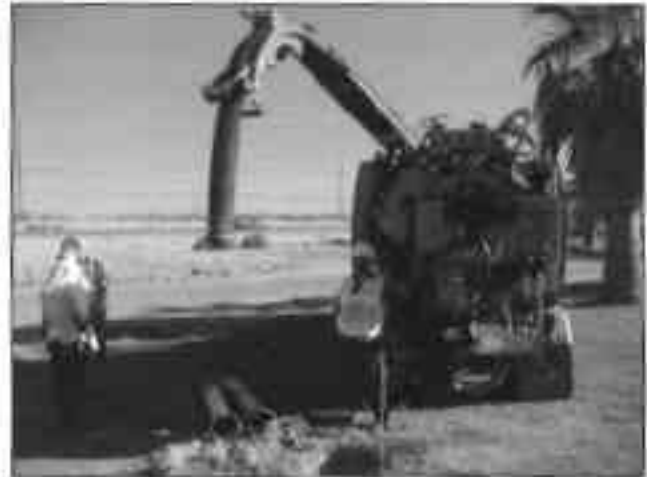
The gravity sewage collection system serving CCSMD was found to be in poor condition due a lack of regular maintenance and large amounts of debris found in the system. Most of the system had to be pumped or cleaned out before being inspected. The pipeline segments that were cleaned and inspected were in generally in good condition with the typical minor issues such as cracked pipes, root intrusions, and offset pipe joints. The original sewer pipelines were installed with slopes and sags that are too flat to be self-cleaning; it is not economical to completely remedy this issue and needs to be addressed through a long-term maintenance program. The sewer system also has inherent problems with maintenance access, as most of the manholes are located in the front and back yards of residences. A preliminary estimate of the capital repairs required for the collection system is \$450,000, including contingencies.

Vactor truck cleaning operations.

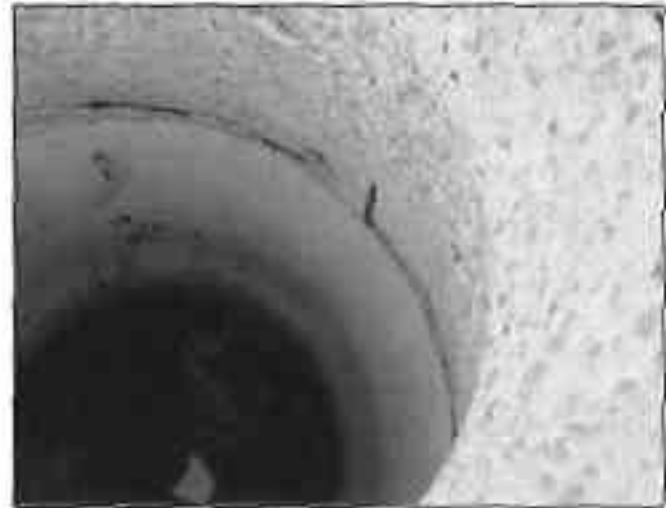
24 of the 34 total manholes within the CCSMD system were inspected and were found to be in fair to very poor condition, depending on location. The remaining manholes were *not found*, buried, or otherwise inaccessible when the inspections were performed. The lower, base portions of most manholes were found to be in good condition, with the upper portions suffering from concrete corrosion, damaged grade rings, poorly fitted frames and covers, and obstructions blocking access to the manhole opening. Most of the manholes had concentric cones and steel rungs, features no longer considered acceptable for safety reasons. A total of \$460,000 in capital improvements is recommended for the CCSMD manholes, including contingencies.

Manhole 5 showing corrosion.

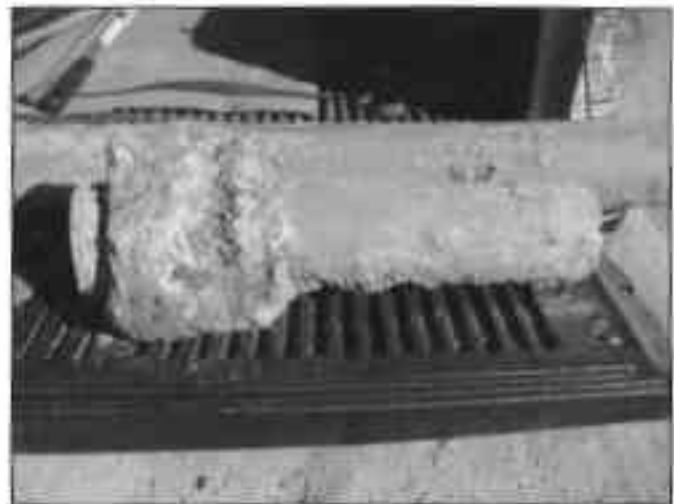
The sewer force main from the pump station was evaluated and found to be undersized from a hydraulic perspective, not allowing the pumps to function in their optimum operating range. The existing force main has also ruptured at least three times in the past several years, most likely due to the marginal strength rating of the original pipe, poor quality control during the initial construction, heat degradation of the pipe material, and pressure spikes from the newer, more powerful pumps. A preliminary estimate of \$740,000 in improvements, including contingencies, are recommended for the sewer force main, the bulk of which is replacement of the existing four-inch force main with a six-inch pipeline.

Existing 4-inch force main pipe removed from the trench.

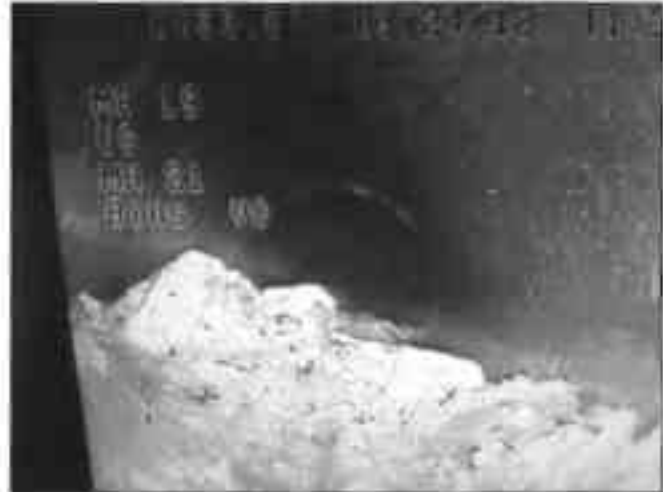
Image taken directly from CCTV camera shows an 8-inch pipeline between MH 19 and 21 that is 25%+ full of silt and debris.

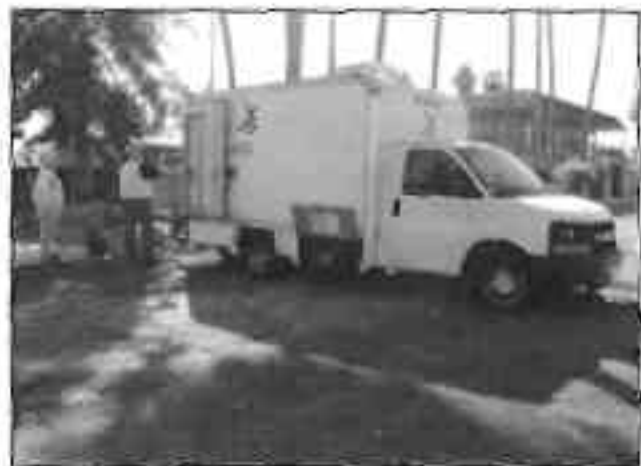
Video inspection operations at MH 26. Note the location of the manhole and sewer line at the rear of the van within private backyards; this is one of the more accessible locations.

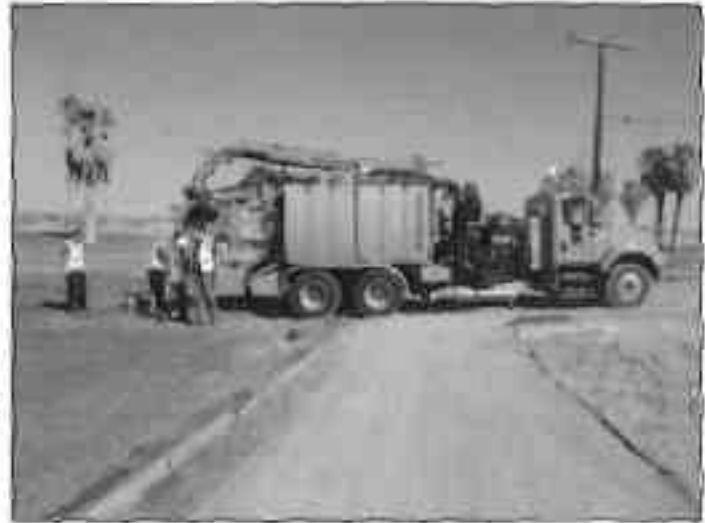
Vactor truck cleaning operations at newly located MH 7 within the golf course. Note the size of the equipment required to efficiently maintain the system.

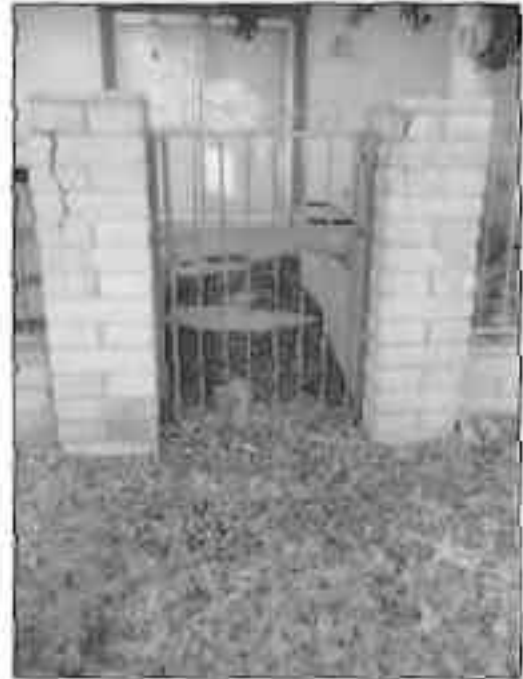
Location of MH 25 within a private patio, as located by the video camera with a tracking device.

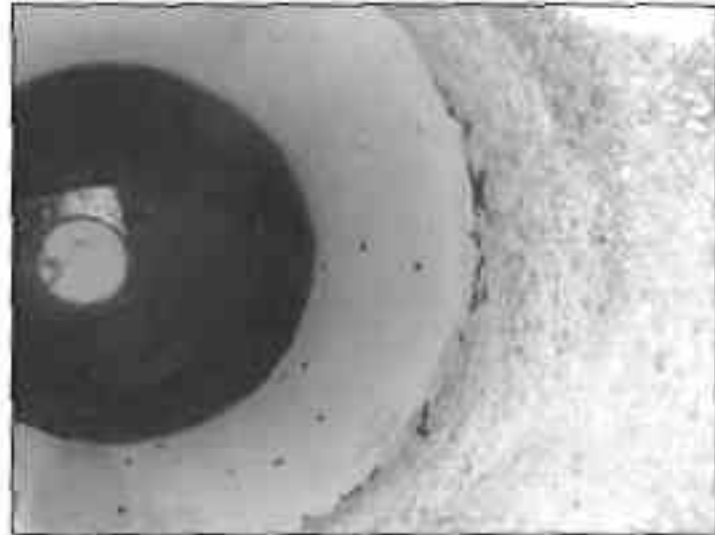
As with the sewer mains, the manholes are also suffering from lack of regular maintenance. The interior surfaces of many of the manholes were originally lined with a bituminous coating. This coating has now largely flaked and peeled off to such a point that it is ineffective, exposing the concrete rings and cone to corrosion from hydrogen sulfide sewer gases. Many cases of concrete corrosion were observed in the field due to the trapped gas, high temperatures, and confined atmosphere. Many of the manhole troughs and shelves were deteriorating in a similar manner.

Typical concrete corrosion found within the cone of many of the CCSMD manholes. The concrete cone on the right should be smooth with no exposed aggregate, similar to the section below.

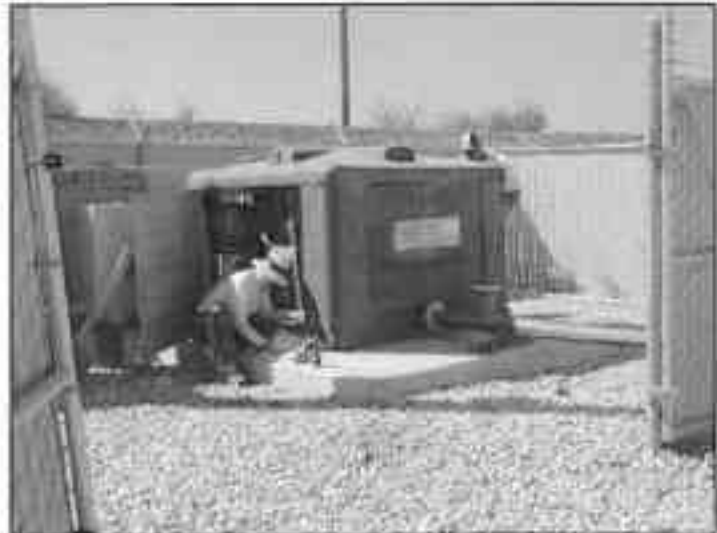
Performance of pump station data collection and operational tests. The pump station was last upgraded in 2004 and was found to be in acceptable condition, with only minor modifications required.

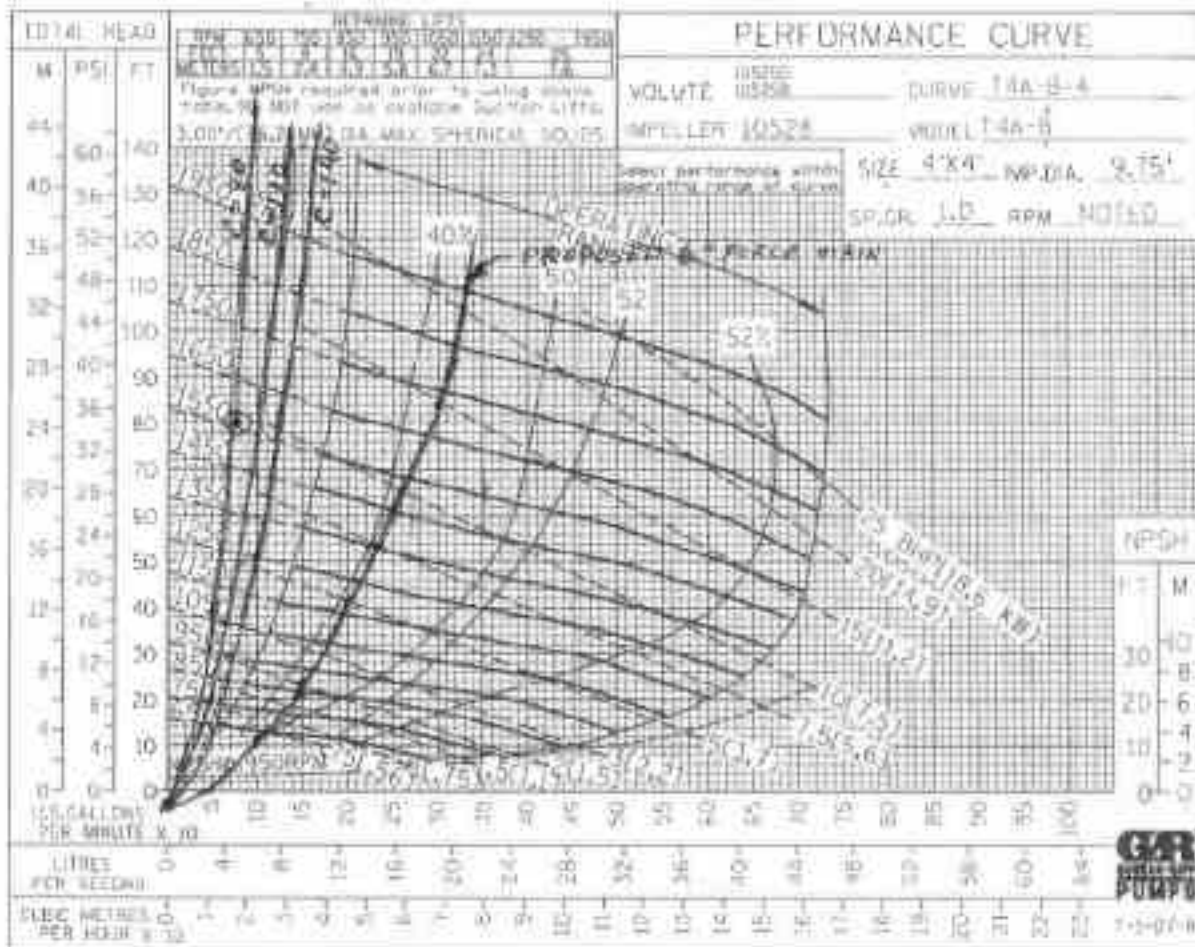
Field measurements indicate the pump station delivers approximately 75 gallons per minute (gpm). However, inspection of the force main indicates the actual flow may be higher due to a relatively clean force main.

Figure 1: Gorman-Rupp T4A-B-4 Pump Performance Curve. Note the circled point on left side, which represents the operating point for the existing pumps and is outside the manufacturer's preferred operating range. Replacement of the force main with a six-inch pipeline would bring the curve back into the optimum operating range as indicated by the hand drawn curve.

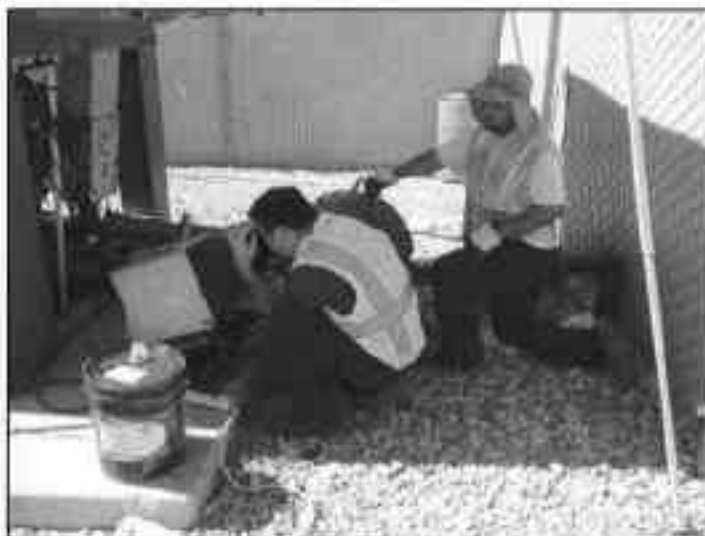
Initial video inspection of the force main with a push camera. Pump station is on the left and force main is on the right. Note the sharp 90-degree bend in the force main next to the fence.

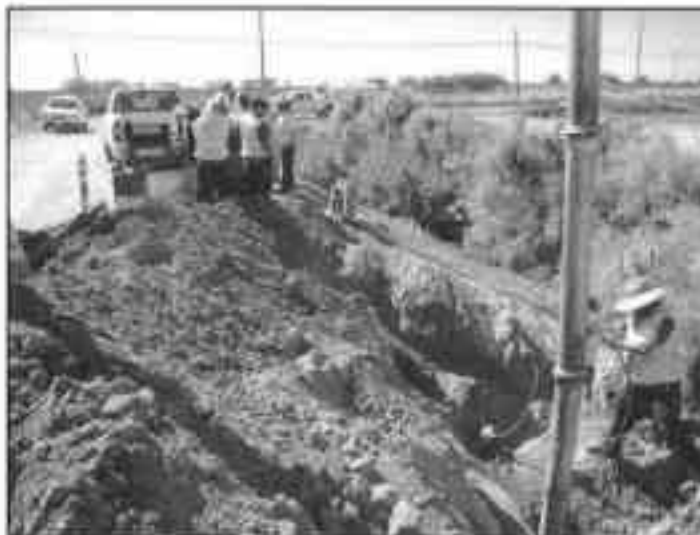
Second video inspection of the force main along Barbara Worth Drain, pump station is in the left background. The end of the pipeline can be seen in the trench, one line in the pipe is the video cable, the other is the jetter line used to pull the camera into the pipe.

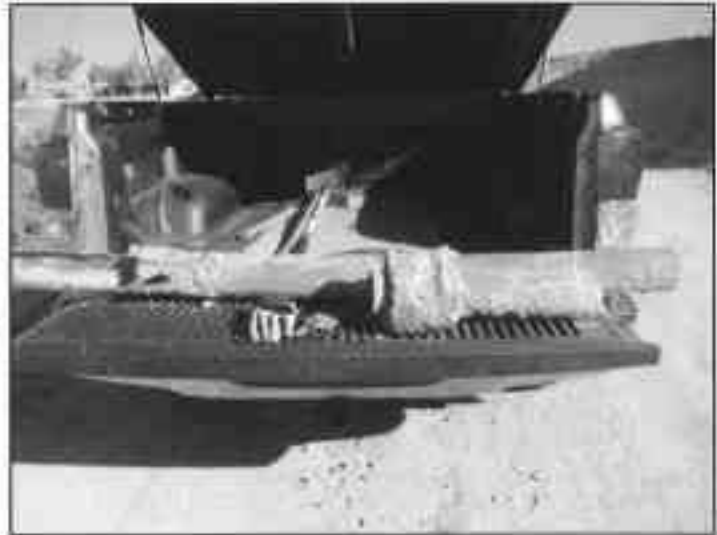
be even more of a concern on a force main which experiences pressure spikes due to pump operations, as opposed to a gravity-fed water supply main which would normally see consistent pressure levels. PVC pipe is also sensitive to ultraviolet (UV) radiation if installed or stored outdoors for extended periods without protection. Older, above-ground sections of pipe at the pump station had some indications of UV degradation, although it is not known if UV exposure contributed to the cracking or splintering of the force main sections that were inspected. It is more likely that the crack was caused by rough handling of the pipe at the time of installation.

Existing 4-inch force main pipe removed from the trench. Note the splintered section on the left, repair coupling in the middle, and the barely visible chip and crack in the spigot end of the shorter section on the right.

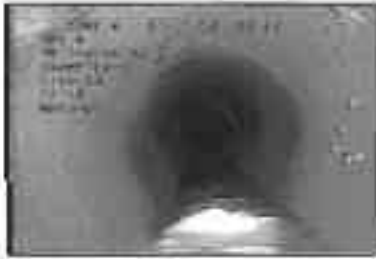
Date: 09/25/2012
 Distance: 323.1 Ft
 Obs: Crack longitudinal
