Subject: Request for Proposal (RFP) for an Initial Study for the Installation of a New Force Main Pipeline, Repairing Pump Station to include Telemetry Equipment.

Project Name: Initial Study for Country Club Sewer Maintenance District (CCSMD).

PRELIMINARY ENGINEERING REPORT (PER) FOR FORCE MAIN REPLACEMENT AND PUMP STATION UPGRADES

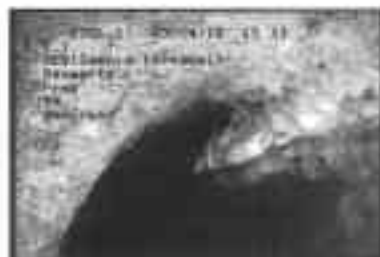
Date: 09/24/2012
Distance: 1.1 ft
Obs: Dark (Grease)

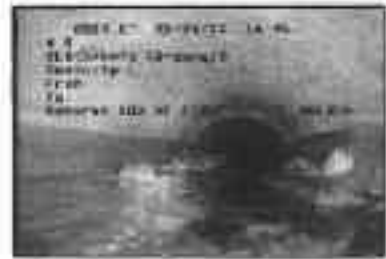
Date: 09/24/2012
 Distance: 40 FT
 Obs: Debris (Grease)

Comments:
 50% OF PIPE FULL OF GREASE

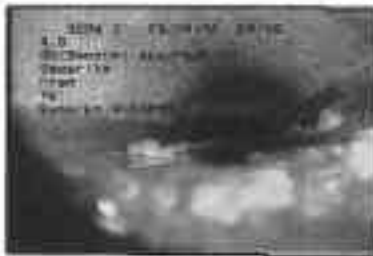
Date: 09/24/2012
 Distance: 40 FT
 Obs: General observation

Comments:
 BLOCKED BY GREASE

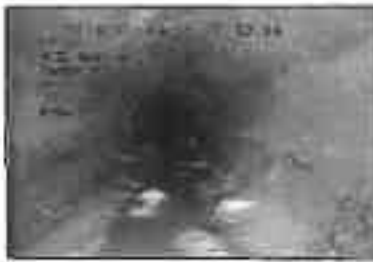
Date: 09/24/2012
 Distance: 14.8 Ft
 Obs: Debris (Gravel)

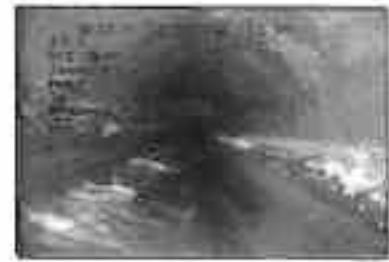
Date: 09/24/2012
 Distance: 23.3 Ft
 Obs: Debris (Gravel)

Comments:
 CONTINUING

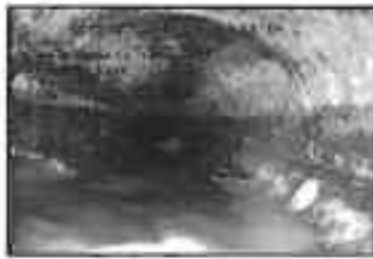
Date: 09/24/2012
 Distance: 26.1 Ft
 Obs: Debris (Gravel)

Comments:
 CONTINUING

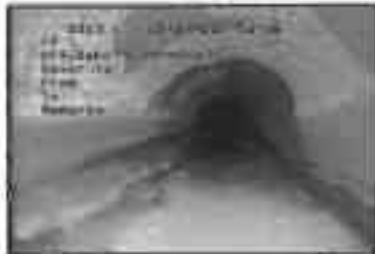
Date: 08/24/2012
 Distance: 16.1 Ft
 Obs: Debris (Discol)

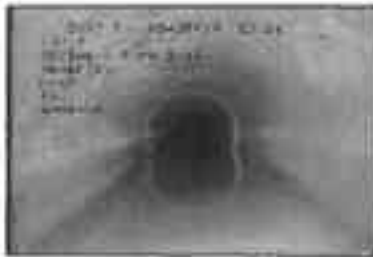
Date: 09/24/2012
 Distance: 157.7 Ft
 Obs: High Pipe Sag

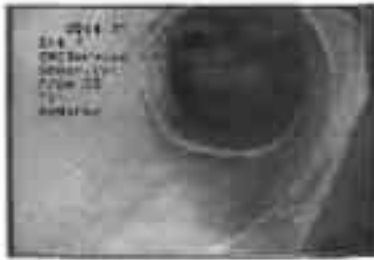
Date: 08/04/2012
Distance: 214.7 Ft
Obs: Barbed Connection

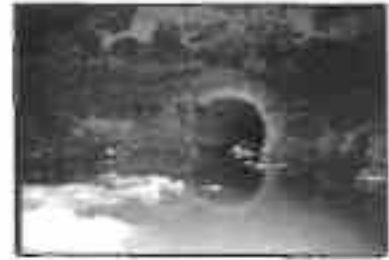
Date: 08/04/2012
Distance: 220.3 Ft
Obs: General observation

Comments:
LARGE DEBRIS IN CS MH

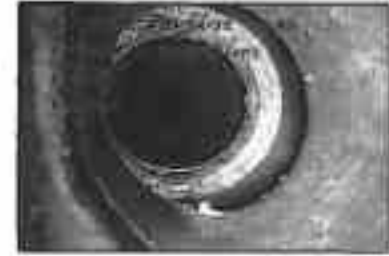
Date: 08/24/2012
 Distance: 30.0 Ft
 Obs: Break in Connection

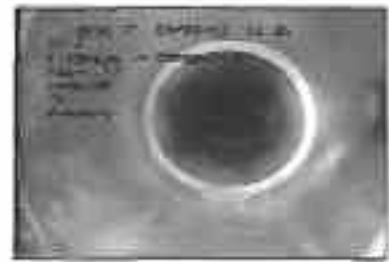
Date: 08/24/2012
 Distance: 20.2 Ft
 Obs: Break in Connection

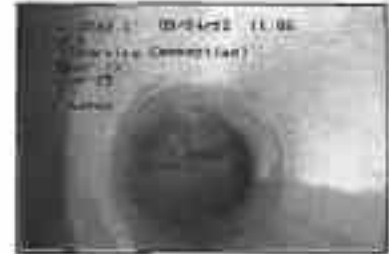
Date: 08/24/2012
 Distance: 45.8 Ft
 Obs: Service Connection

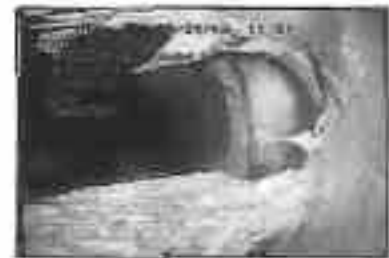
Date: 08/24/2012
 Distance: 101.8 Ft
 Obs: Hydrofracture Lateral

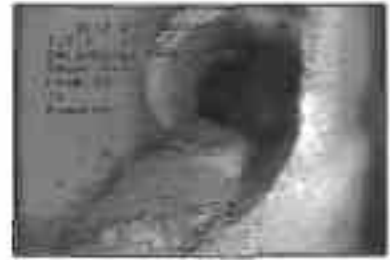
Date: 09/24/2012
 Distance: 112.4 Ft
 Obs: Service Connection

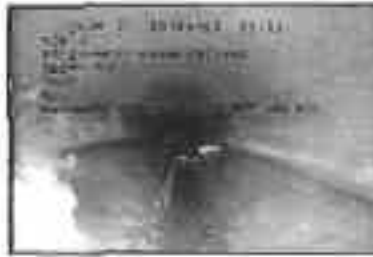
Date: 09/24/2012
 Distance: 134.2 Ft
 Obs: General observation

Comments:
 BLOCKED BY HEAVY GREASE

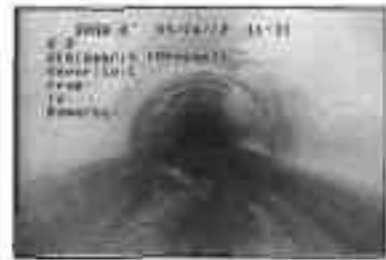
Obs: Debris (Grease)

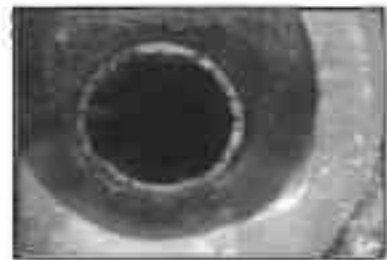
Date: 09/24/2012
 Distance: 9.4 Ft
 Obs: Break In Connection

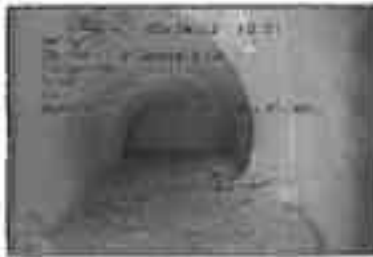
Date: 09/24/2012
 Distance: 34.3 Ft
 Obs: Service Connection

Comments:
 LARGE DEBRIS IN
 LATERAL

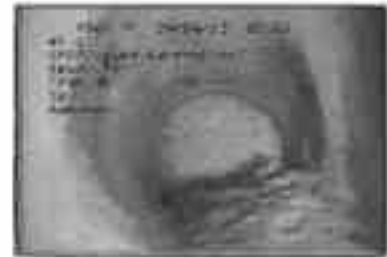
Date: 09/24/2012
 Distance: 45.0 Ft
 Obs: Plugged Connection

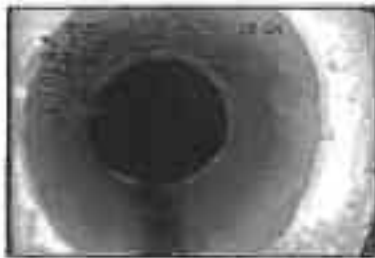
Date: 09/24/2012
 Distance: 75.3 Ft
 Obs: Break in Connection

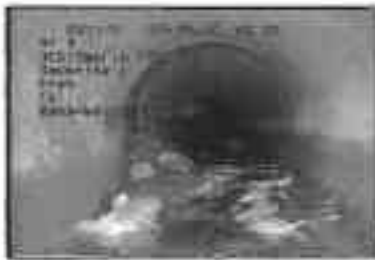
Date: 08/24/2012
 Distance: 87.9 Ft
 Obs: Debris (Grease)

Comments:
 CONTINUING

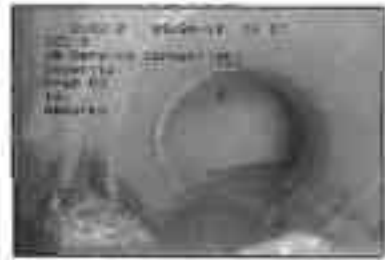
Date: 08/24/2012
 Distance: 103.2 Ft
 Obs: Service Connection

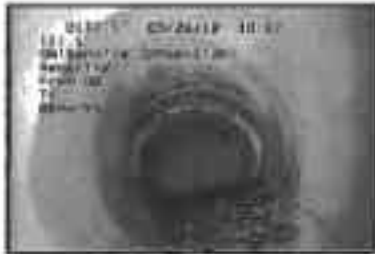
Date: 08/24/2012
 Distance: 111.1 Ft
 Obs: Service Connection

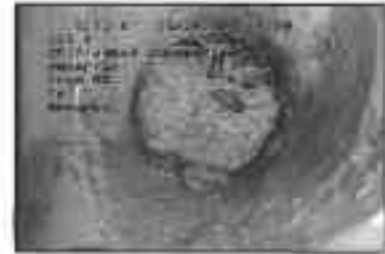
Date: 08/24/2012
 Distance: 113.4 Ft
 Obs: Plugged Connection

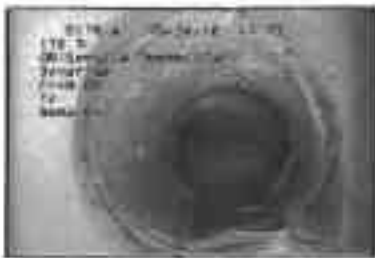
Date: 08/24/2012
 Distance: 179.3 Ft
 Obs: Service Connection

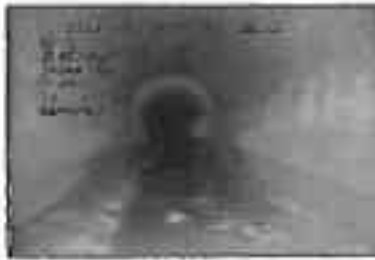
Date: 09/25/2012
 Distance: 12.1 Ft
 Obs: Debris (Ground)

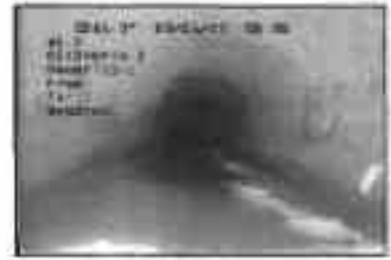
Date: 09/25/2012
 Distance: 45.0 Ft
 Obs: Debris

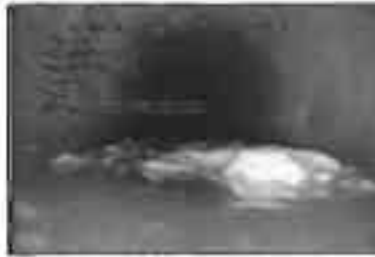
Date: 09/25/2012
 Distance: 103.3 Ft
 Obs: Debris

Comments:
 CONTINUING

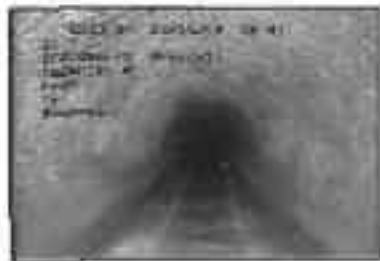
Date: 09/25/2012
 Distance: 31.1 Ft
 Obs: Debris (Onwall)

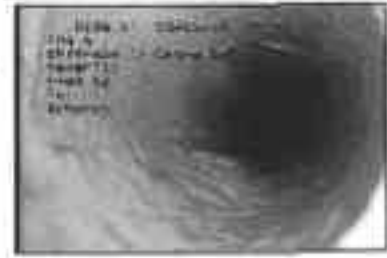
Date: 09/25/2012
 Distance: 104.5 Ft
 Obs: Break in Connection

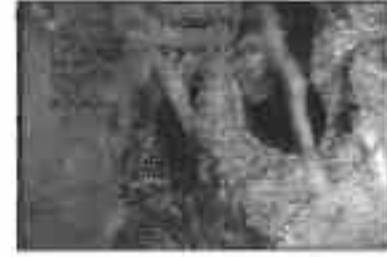
Date: 06/25/2012
 Distance: 320.1 Ft
 Obs: Break in Connection

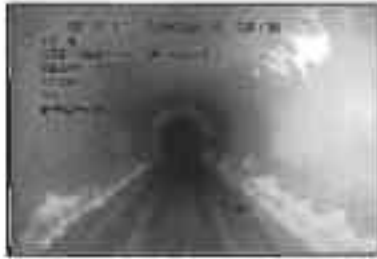
Date: 09/25/2012
 Distance: 10.4 Ft
 Obs: Sinks (Grease)

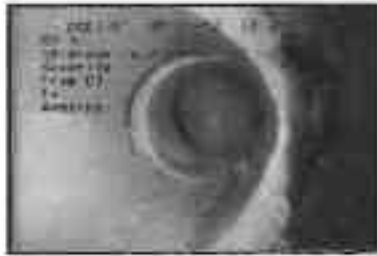
Date: 09/25/2012
 Distance: 63.3 Ft
 Obs: Break in Connector

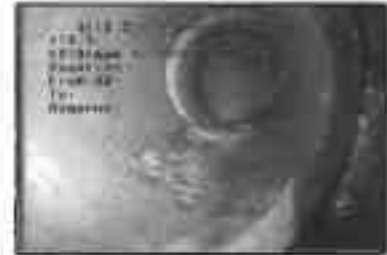
Date: 09/25/2012
 Distance: 112.9 Ft
 Obs: Break in Connector

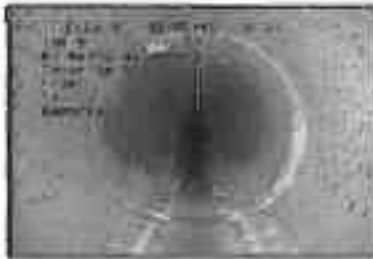
Date: 09/25/2012
 Distance: 150.3 Ft
 Obs: Roots at joint

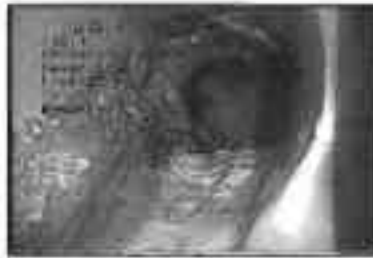
Date: 09/25/2012
 Distance: 106.3 Ft
 Obs: Service Connector

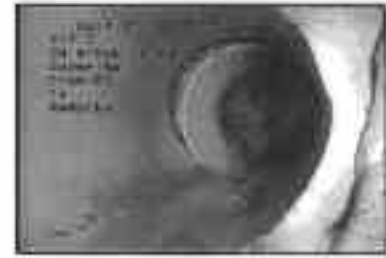
Date: 09/25/2012
 Distance: 217.3 Ft
 Obs: Break in contraction

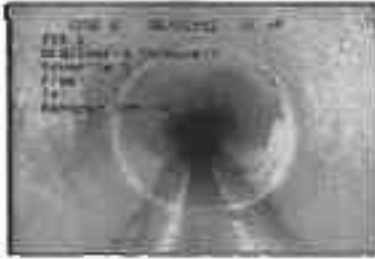
Date: 09/25/2012
 Distance: 263.0 Ft
 Obs: Debris (Grease)

Comments:
 CONTAMINATED

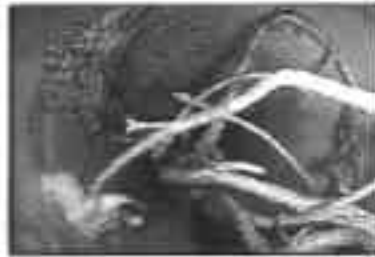
Date: 09/25/2012
 Distance: 355.3 Ft
 Obs: Roots at joint

Comments:
 TAP ROOTS

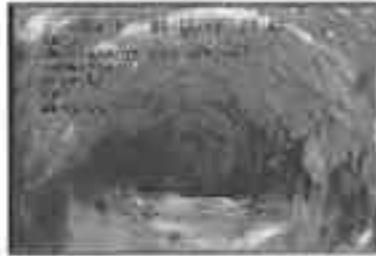
Date: 09/25/2012
 Distance: 16.2 Ft
 Obs: Break in Connection

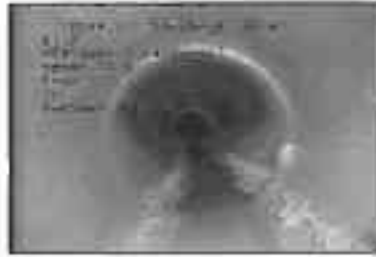
Date: 09/25/2012
 Distance: 61.3 Ft
 Obs: Debris (Sewer)

Comments:
CONTINUING

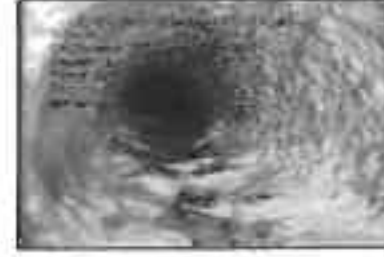
Date: 09/25/2012
 Distance: 105.6 Ft
 Obs: Break in Connection

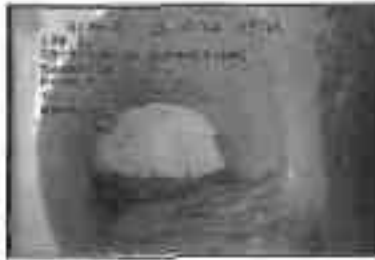
Date: 08/25/2012
 Distance: 128.2 Ft
 Obs: Break in Connector

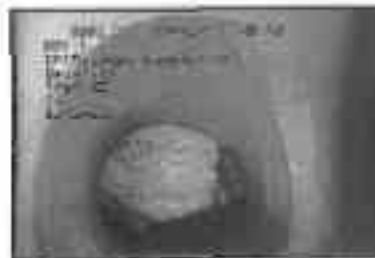
Date: 08/25/2012
 Distance: 251.1 Ft
 Obs: Plugged Connector

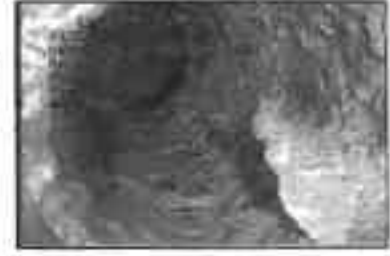
Date: 09/25/2012
 Distance: 303.6 Ft
 Obs: Break in Connection

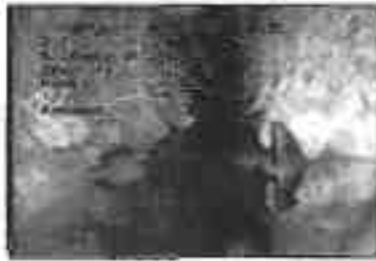
Date: 09/05/2012
 Distance: 2.1 Ft
 Obs: Roots at joint

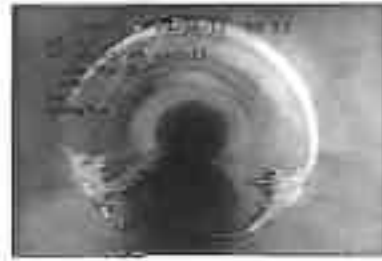
Date: 09/05/2012
 Distance: 50.1 Ft
 Obs: Roots at joint

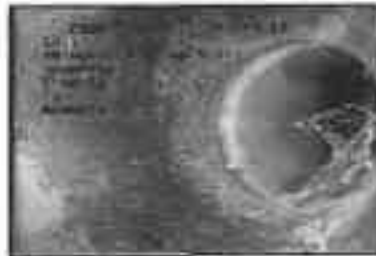
Date: 09/05/2012
 Distance: 83.1 Ft
 Obs: Service Connection

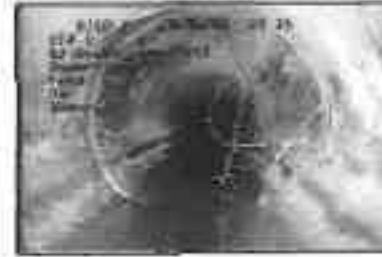
Date: 09/05/2012
 Distance: 116.1 Ft
 Obs: Roots at joint

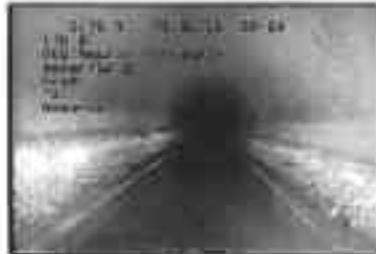
Date: 09/06/2012
 Distance: 170.8 Ft
 Obs: Debris (Greases)

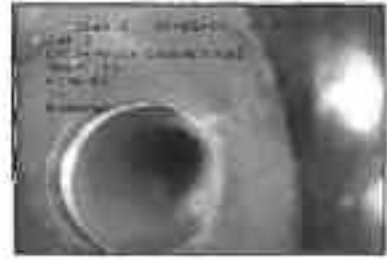
Date: 09/06/2012
 Distance: 144.2 Ft
 Obs: Service Connection

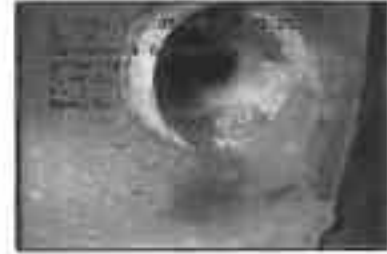
Date: 09/06/2012
 Distance: 251.3 Ft
 Obs: Service Connection

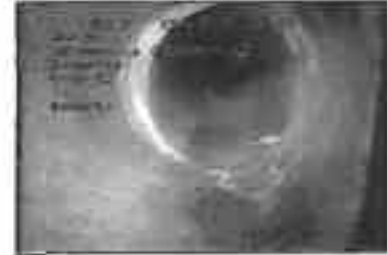
Date: 09/06/2012
 Distance: 328.8 Ft
 Obs: Service Connection
